SERVICE BULLETIN

Date:	03/22/2024		
Document Number:	TM-VPK-010		
BULLETIN TYPE:	Internal and External	Subject:	Indoor Motor Wiring
PRODUCTS AFFECTED:	VHA18-RTQ	Author:	Technical Management

Vert-I-Pak 18 Motor Rewire

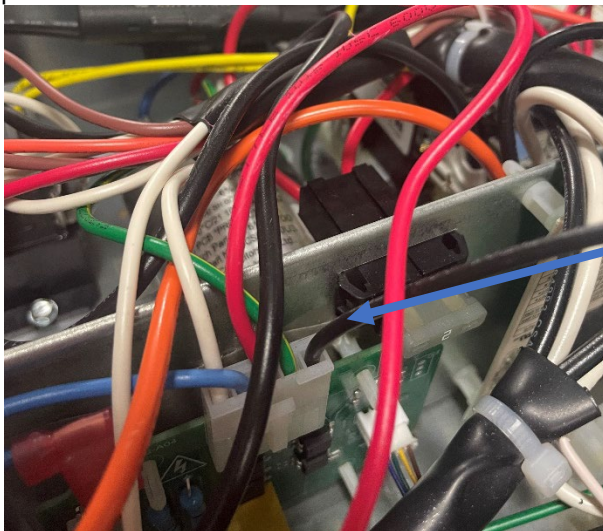
Disconnect the black wire from the contactor

- Cut wire tie to free the L1 (Black) wire off the small blower control board. Remove the wire from the contactor pole.
